# REPAIR OF HISTORICAL CONCRETE STRUCTURES MONTGOMERY WARDS CATALOG BUILDING

Rhocel O. Bon and Jay H. Paul  
Klein and Hoffman, Inc.

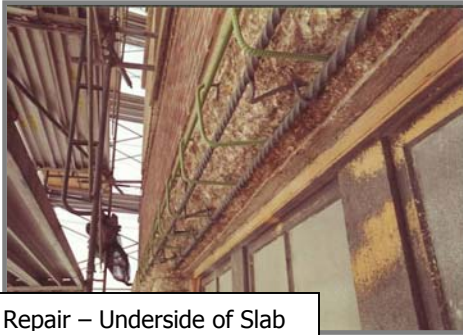
Repair – Underside of Slab

Repairs to the underside of the slab (window head) were also necessary throughout. Original twisted bars were found with corrosion ranging from marginal to very significant. Other existing reinforcing steel was found with minimal concrete coverage.

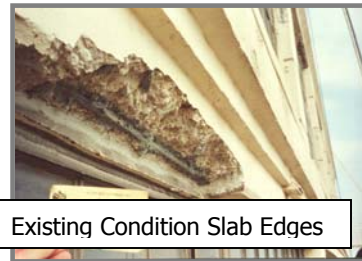
Existing Condition Slab Edges

Several concrete repairs were needed to address the varying conditions encountered. The most prevalent defect noted was delamination of the exposed slab edges. These slab edges also served as window heads for the existing wood frame windows that were set well into the space. Repair of the slab edge ranged from isolated repairs at the bottom corners of the slab to complete removal (for depths up to 6”) for the entire width of the window openings.

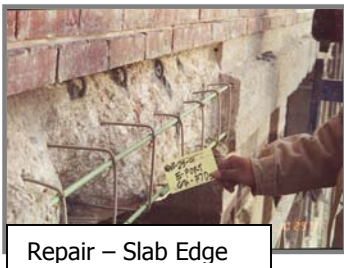
Repair – Slab Edge

At each of the concrete repair areas, the delaminated concrete was carefully removed until 'sound' concrete was located. Fortunately, the deep inset of the windows did not require repairs that extended to the interior spaces. Where possible, existing reinforcing steel was reused after it was cleaned and coated with a zinc-rich primer. The contractor was careful not to apply the primer onto the existing concrete since it could act as a bond breaker.

Due to the minimal reinforcing in the exposed slab edges it was important to provide supplemental steel in the form of threaded rods to help anchor the new repairs. The threaded rods were embedded in the parent concrete to remain and secured with epoxy. Spacing of the threaded rods depended on the size and extent of the repairs. In some instances multiple rows of rods were provided.

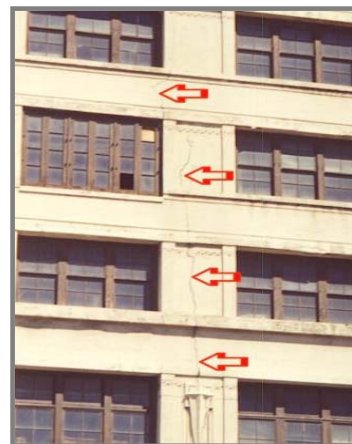
During our inspection of 100% of the exterior facades, we noted significant vertical cracks on the west elevation. A review of the available drawings revealed to us that the cracks observed corresponded to the original location of the expansion joint (west elevation). The original expansion joint, which consisted of steel plates, angles and bees wax had corroded and was ineffective. Consequently, nature created its own expansion joint with the crack observed.

Similar cracks (not as severe as was found on the west elevation – column line 7) were found at the location of the other expansion joints. At each of these locations, Klein and Hoffman designed new expansion joints to reestablish what was originally provided. The design that was developed involved  $\frac{3}{4}$ " bearing shoes (stainless steel) and two-ply neoprene pads (in place of the bees wax). The detail also involved additional concrete restoration at each of the spandrel sections. Our detail was found to be cost prohibitive and an alternative detail was developed. The revised detail involved grinding, pressure grouting and sealing the continuous vertical cracks. Half-inch diameter threaded rods (set in epoxy) were installed along each side of the cracks (which extended through the depth of the columns) at one-foot intervals (vertically) to 'stitch' the column together.
