# REPAIR OF HISTORICAL CONCRETE STRUCTURES MONTGOMERY WARDS CATALOG BUILDING

Rhocel O. Bon and Jay H. Paul  
Klein and Hoffman, Inc.

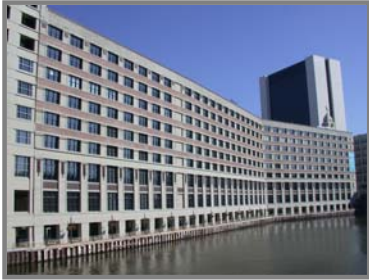
Similar cracks (not as severe as was found on the west elevation – column line 7) were found at the location of the other expansion joints. At each of these locations, Klein and Hoffman designed new expansion joints to reestablish what was originally provided. The design that was developed involved  $\frac{3}{4}$ " bearing shoes (stainless steel) and two-ply neoprene pads (in place of the bees wax). The detail also involved additional concrete restoration at each of the spandrel sections. Our detail was found to be cost prohibitive and an alternative detail was developed. The revised detail involved grinding, pressure grouting and sealing the continuous vertical cracks. Half-inch diameter threaded rods (set in epoxy) were installed along each side of the cracks (which extended through the depth of the columns) at one-foot intervals (vertically) to 'stitch' the column together.

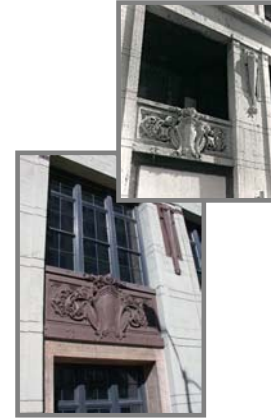
One of the interesting outcomes of the removal of the existing coating was the revelation that areas above the piers that we suspected were decorative concrete were in fact terra cotta. Typically, terra cotta repairs can be difficult due to the underlying steel that is often implemented to secure the material. In the case of the Catalog Building, the terra cotta was cast with the concrete. For the most part, the terra cotta was in very good condition considering the age of the building. The terra cotta became an issue when it came to restoring its original color.

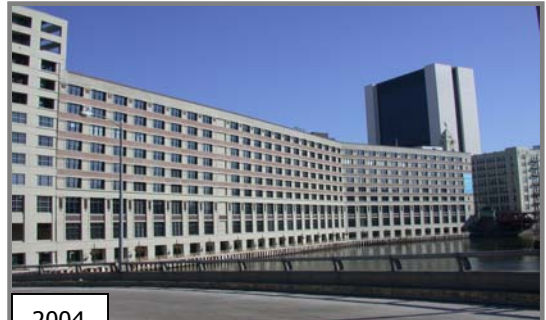
2004

the same but the depth increased with the removal of the exterior walls. The completed work recalls the original design of the building with the strong sense of horizontality re-established.
