## **415 Aldine: The Repair of Terra Cotta Facades**

By Philip G. Renouf  
President  
Klein and Hoffman, Inc.

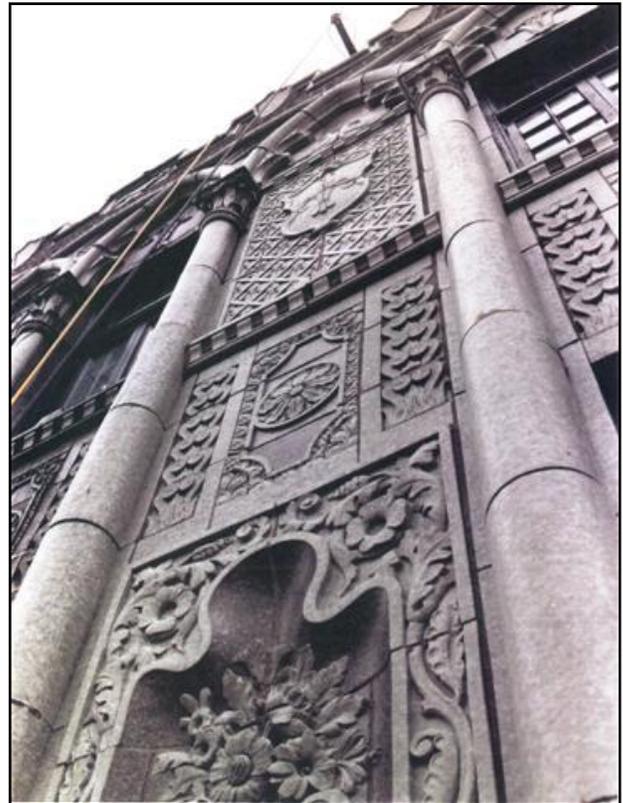
Built in the 1920s, the neoclassical structure uses the image of a column to visually organize the architectural elements. The lower floors that form the base are clad with ashlar limestone. A decorative band of terra cotta above the third floor marks the transition to the "body" of the column. The middle floors employ a matrix of brick and windows that form a simple but strong vertical line that leads the eye upwards. The top three floors abound in an intricate display of Gothic decoration comprised of ornate terra cotta window surrounds, continuous cornices, finials, intricate spandrel panels, medallions in the crenelated (i.e. sawtoothed) parapet and half round columns between the windows.
