This article was originally published in Concrete International, the magazine of the American Concrete Institute, August 1998.

CONCRETE TANK INSPECTIONS

By Jay H. Paul, SE, PE, FACI, Senior Principal

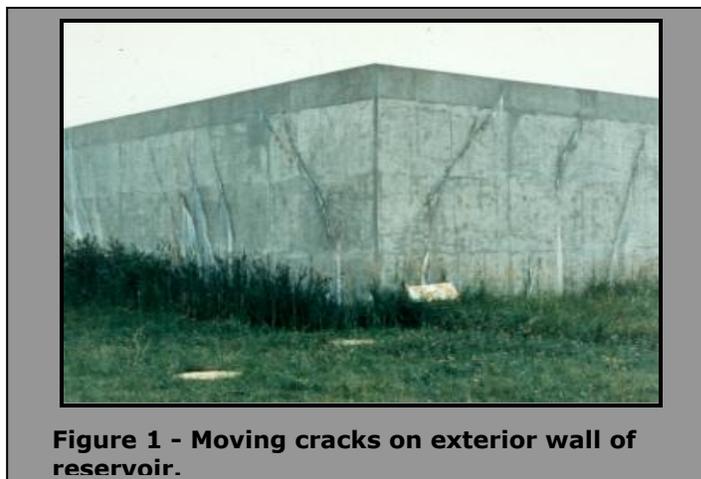
Figure 1 - Moving cracks on exterior wall of reservoir.

Diagonal cracks are found most often near corners, and vertical cracks appear more frequently along the length of the tank (Fig. 1). Generally, both types of cracks are not structural in nature - they're due to volumetric changes in length. Cracks in walls are less likely to be a source of contaminate infiltration. Instead, they tend to be sources of leaks from the tank (see photo on p. 62).

Most cracks in exposed tank walls move and change in width with seasonal temperature changes. Tanks with moving cracks will leak more in the winter than in the summer, when the cracks tend to close. As a result, it is common to see ice forming at the cracks in colder months.

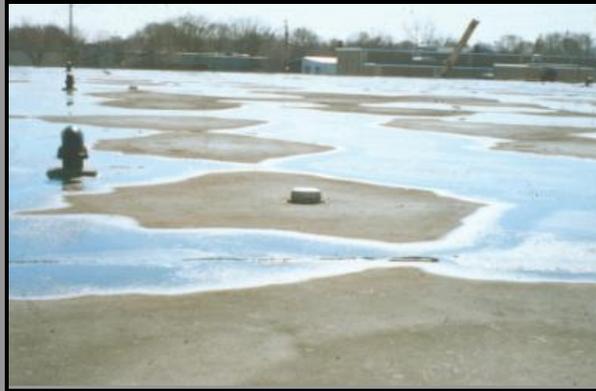
Figure 3 - Ponding water on roof deck drains are located over columns as opposed to low points of slab.

Most often when drains exist, they are placed within the columns. However, they frequently are not effective. Deflection occurs in the slab areas between columns where water accumulates until it can evaporate (Fig.3). If any cracks are present within these low areas, water will eventually penetrate the slab unless sealants or membranes are provided to alleviate the problem.

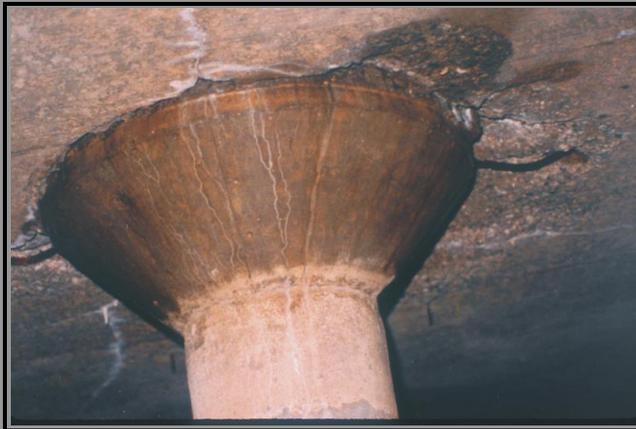
Figure 4 - Punching shear failure at capital of reservoir.

Poor detailing: Many problems occur due to poor detailing. The lack of proper expansion joints, improperly placed control joints, and insufficient roof slopes are quite common. Very serious structural problems can result if adequate overflows are not provided in the structures. Should an accidental overflow condition occur, internal pressures pushing against the underside of the top slab can result in punching shear failures (Fig. 4).
