Terra Cotta Restoration

By Philip G. Renouf
President
Klein and Hoffman, Inc.

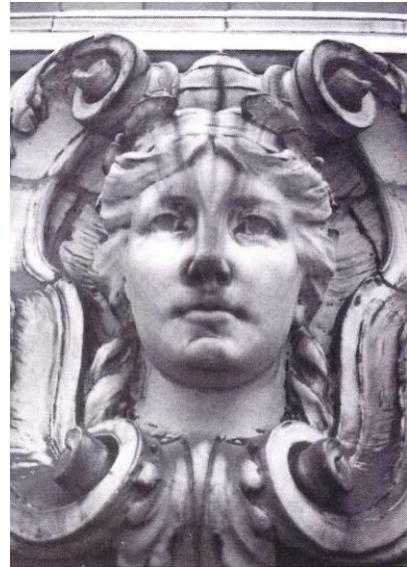
Close up of typical terra cotta work found on many Chicago area properties.
